Manhole Inspection Summary

Manhole # S47I__043MH

Location Address: **2119 bank alley eastern**

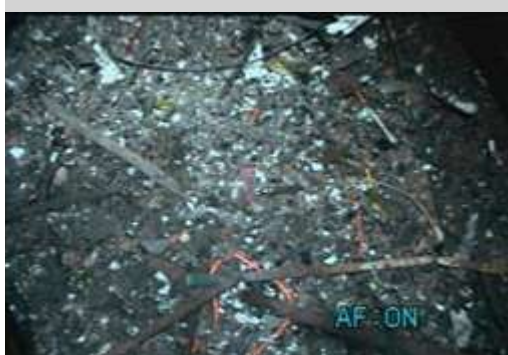
Defect 3

Condition: ☐ Sound ☐ Cracked ☐ Root Intrusion ☐ Deteriorated ☐ Leaks ☒ **Debris**

channel debris

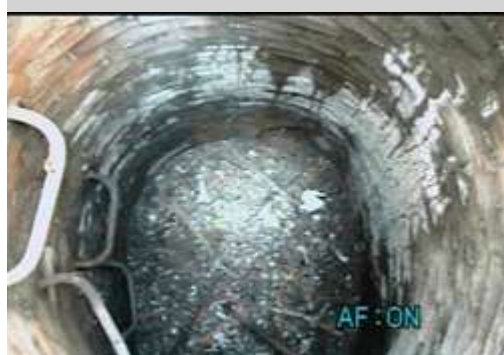
Defect 4

Infiltration: ☐ None ☐ Joint ☐ Cracks ☐ Mortar ☐ Roots ☒ **Wall**

infiltration from corbel wall

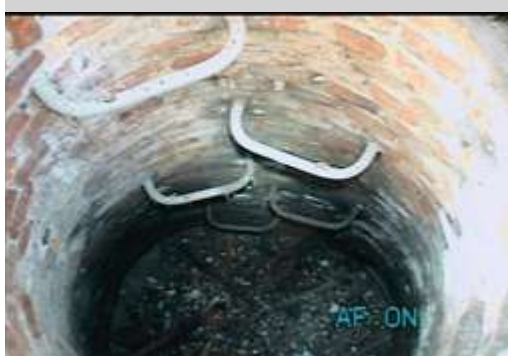
Defect 2

Steps Count: **5** Missing: **0** ☒ **Corroded**

corroded stairs

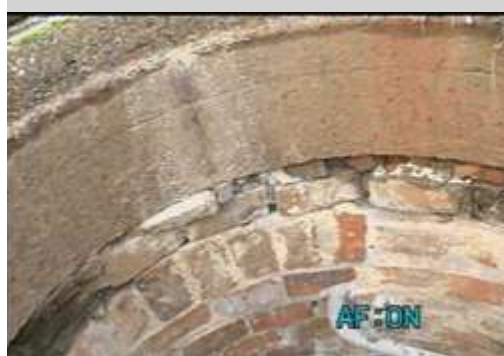
Defect 1

Condition: ☐ Sound ☐ Cracked ☐ Root Intrusion ☒ **Loose Brick** ☐ Deteriorated

chimney loose brick
